COY-TR-66-509

MAY 1966

**AIRMUNITIONS TEST REPORT**

**MINUTEMAN  
(LGM-30)  
IMPALER TEST**

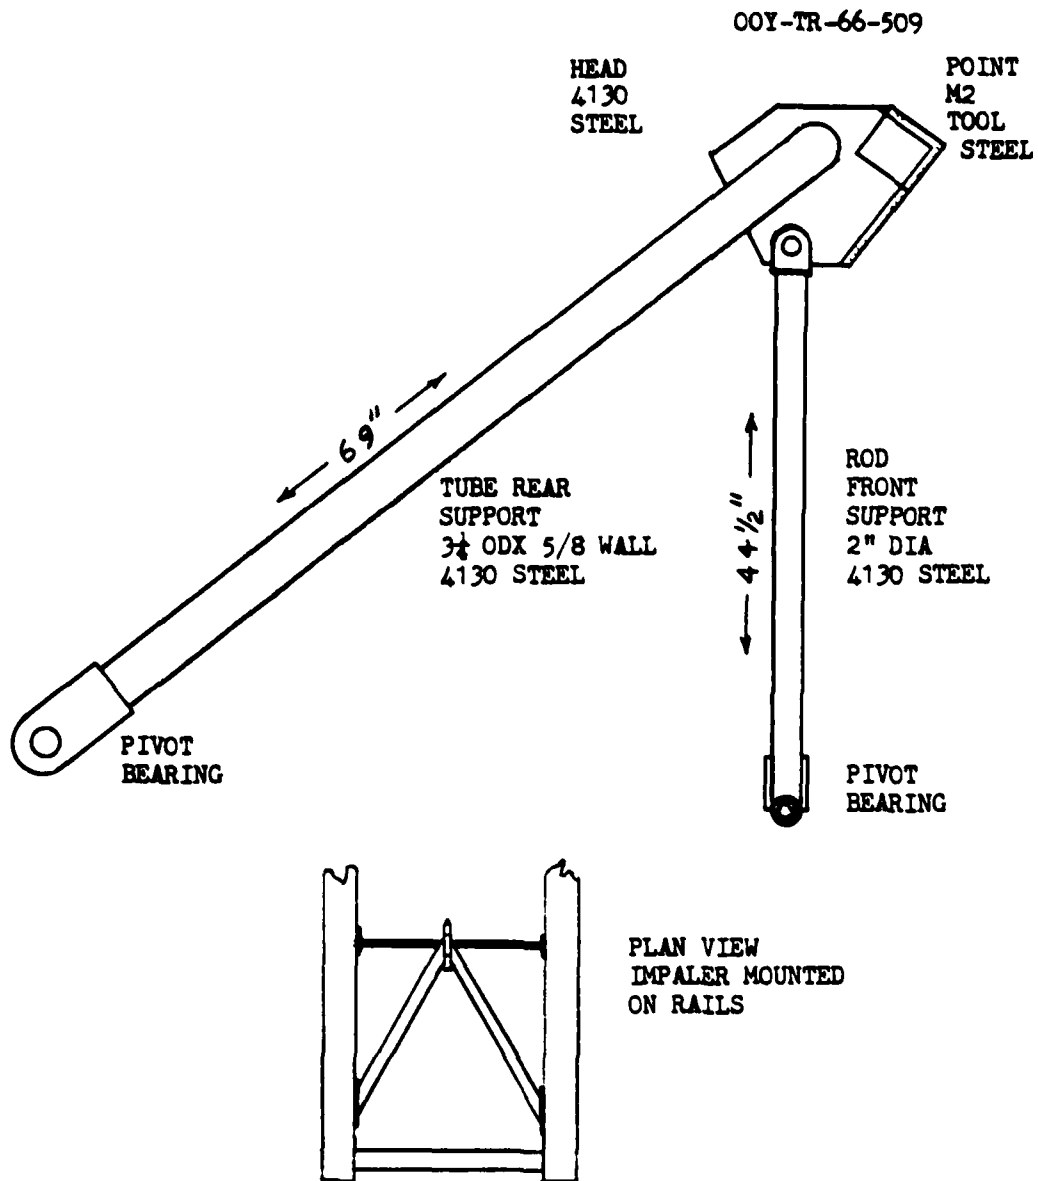
FIGURE 6. IMPALER

The impaler (Figure 6) consisted of a steel head supported by four steel legs. A hardened steel point was silver soldered into the head. The impaler has been designed to mount between the rails and to pivot downward to allow passage of motor carriages.
